PLAYGROUND SAFETY INSPECTION REPORT

**Stanford Recreation Park
Stanfordville, NY**

**Inspected
May 20, 2022
By Lee Archin, CPSI**

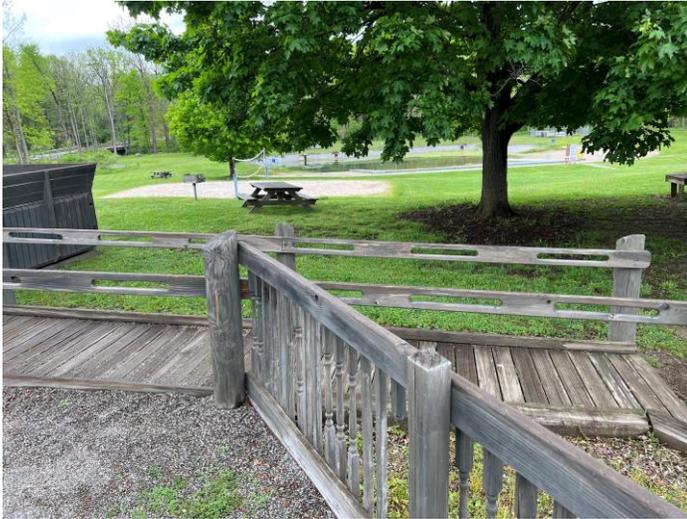
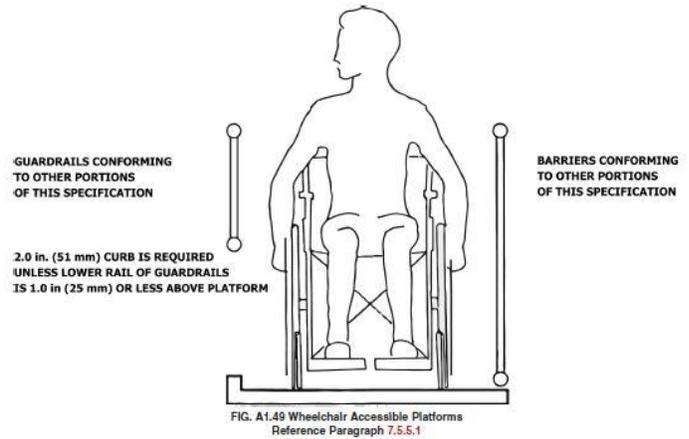
Ramp Rails: *Fair condition*

Issues: Handrails do not comply with current ADA guidelines. All accessible ramps should have two handrails on both sides (ASTM 7.5.5.5) (**Priority 3**)

Recommendation: Install ADA compliant handrails 12"-16" and 26"-28" above the ramp on both sides where possible.

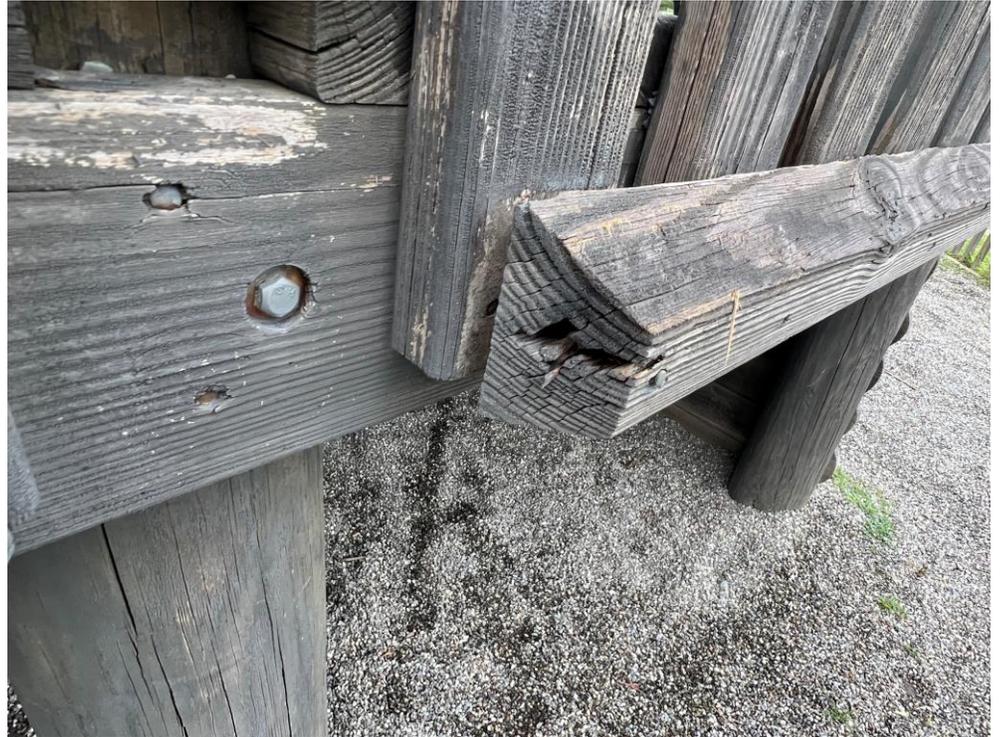
Framing: *Fair condition*

Issues: Exposed framing show slight signs of weathering and splitting
(Priority 3)

Recommendation: Sand and seal all exposed framing. Rout edges with $\frac{1}{4}$ " radius so the top of the boards is less than 2" of a flat surface.

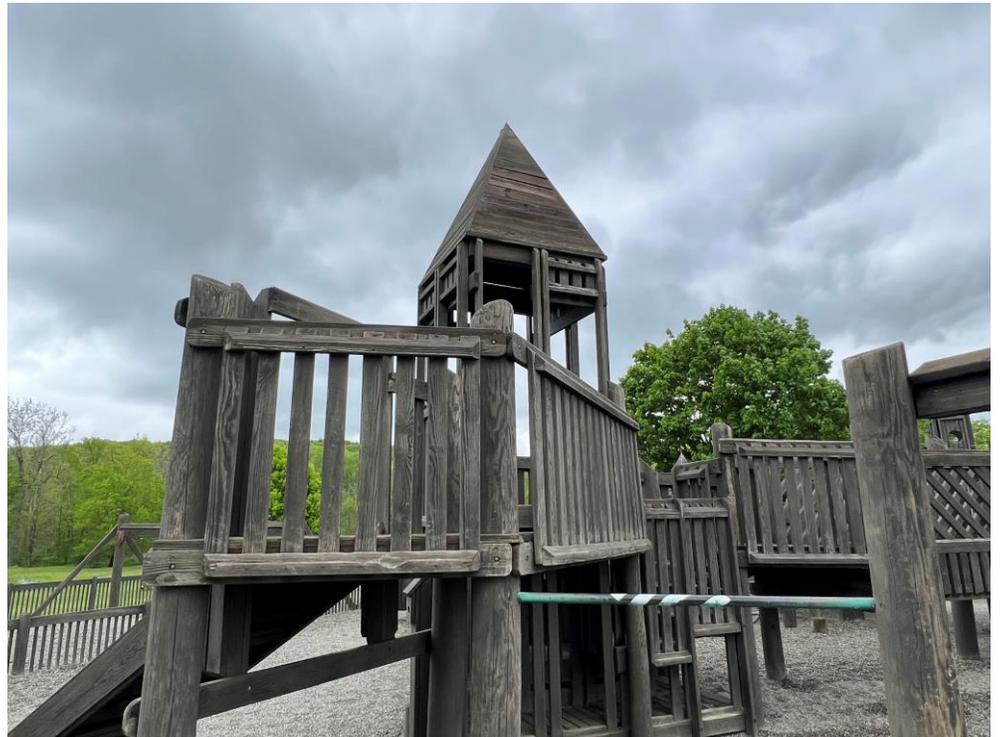
Handrails & Balusters: *Poor Condition*

Issues: Exposed handrails and balusters show signs of weathering and splitting.
(Priority 1)

Recommendation: Sand and seal all exposed framing. Rout edges with $\frac{1}{4}$ " radius so the top of the boards is less than 2" of a flat surface. Some areas are too damaged to fix, consider replacing with a structural plastic lumber material. Balusters can be replaced with plastic lumber 2x2 that will remedy the issue and increase line of site .

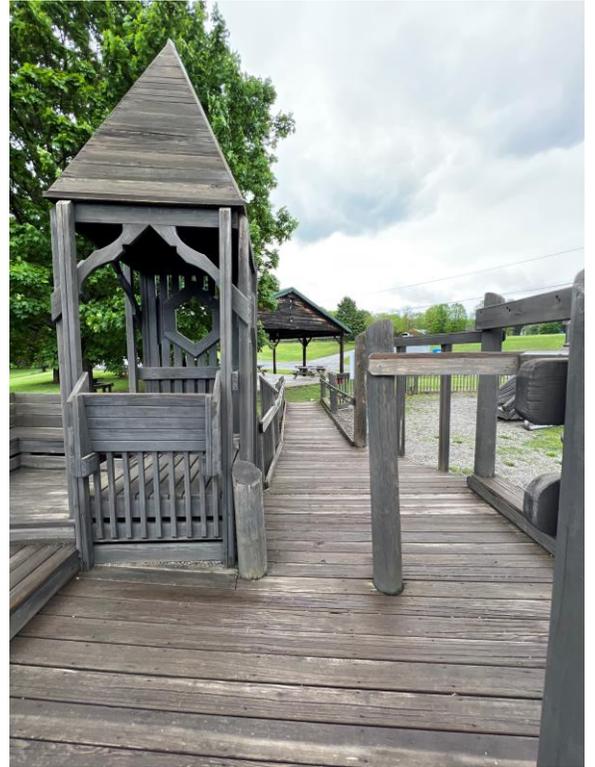
Roofs: Poor Condition

Issues: The spaces created by the diagonal bracing creates a head entrapment. (**Priority 1**). Space is over 3-1/2" and less than 9".

Recommendation: Remove

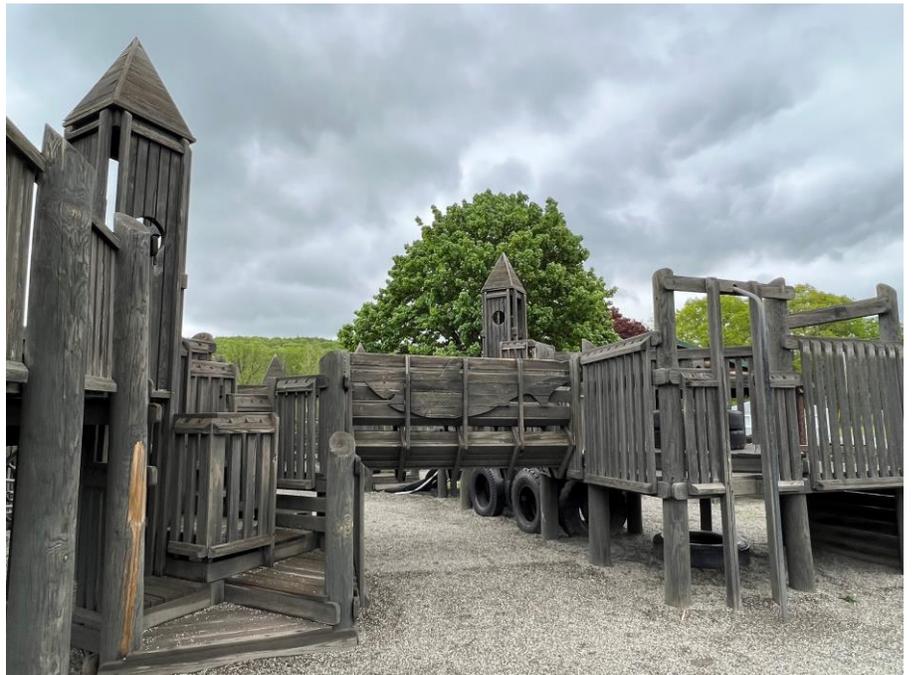
Fish Tunnel: Poor Condition

Issues: The space between the post and baluster at the fish tunnel creates a head entrapment. (**Priority 1**). Space is over 3-1/2" and less than 9".

Recommendation: Add filler pieces so spacing is less than 3-1/2".

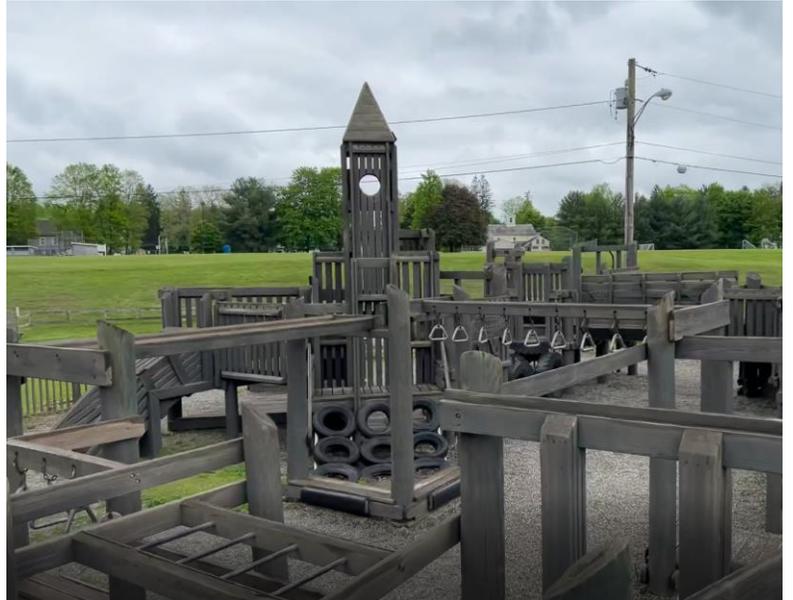
Play Element Tire Cube Climber: *Poor Condition*

Issues: Entrapment at top at both ends of tire cube climber, between vertical 2x4s and posts. (**Priority 1**). Space is over 3-1/2" and less than 9".

Recommendation: Add filler pieces so spacing is less than 3-1/2" or remove.

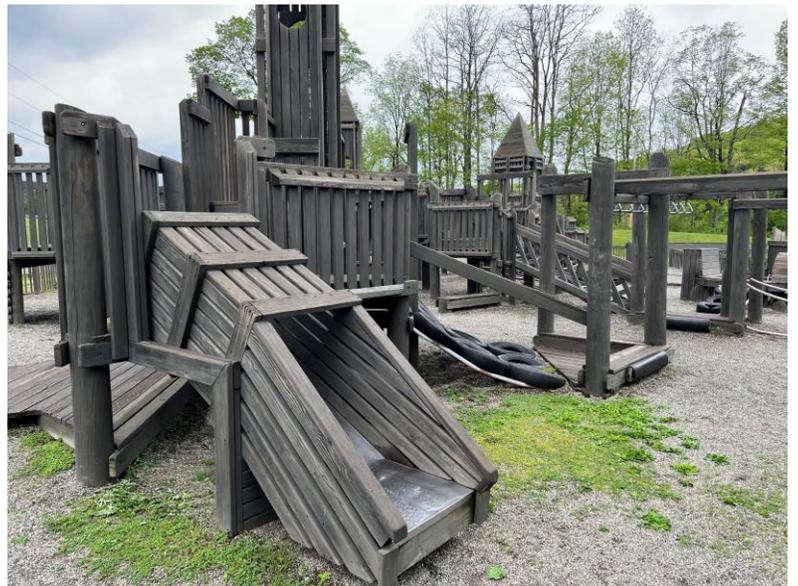
Play Element Tunnel Slide: *Poor Condition*

Issues: Angle of entrapment between vertical 2x4s and post at tunnel slide. (**Priority 1**). Space is over 3-1/2" and less than 9". Wood is splitting due to age. No grab bar at top of slide entry. Walking surface, greater than 2".

Recommendation: Remove and replace with manufactured slide.

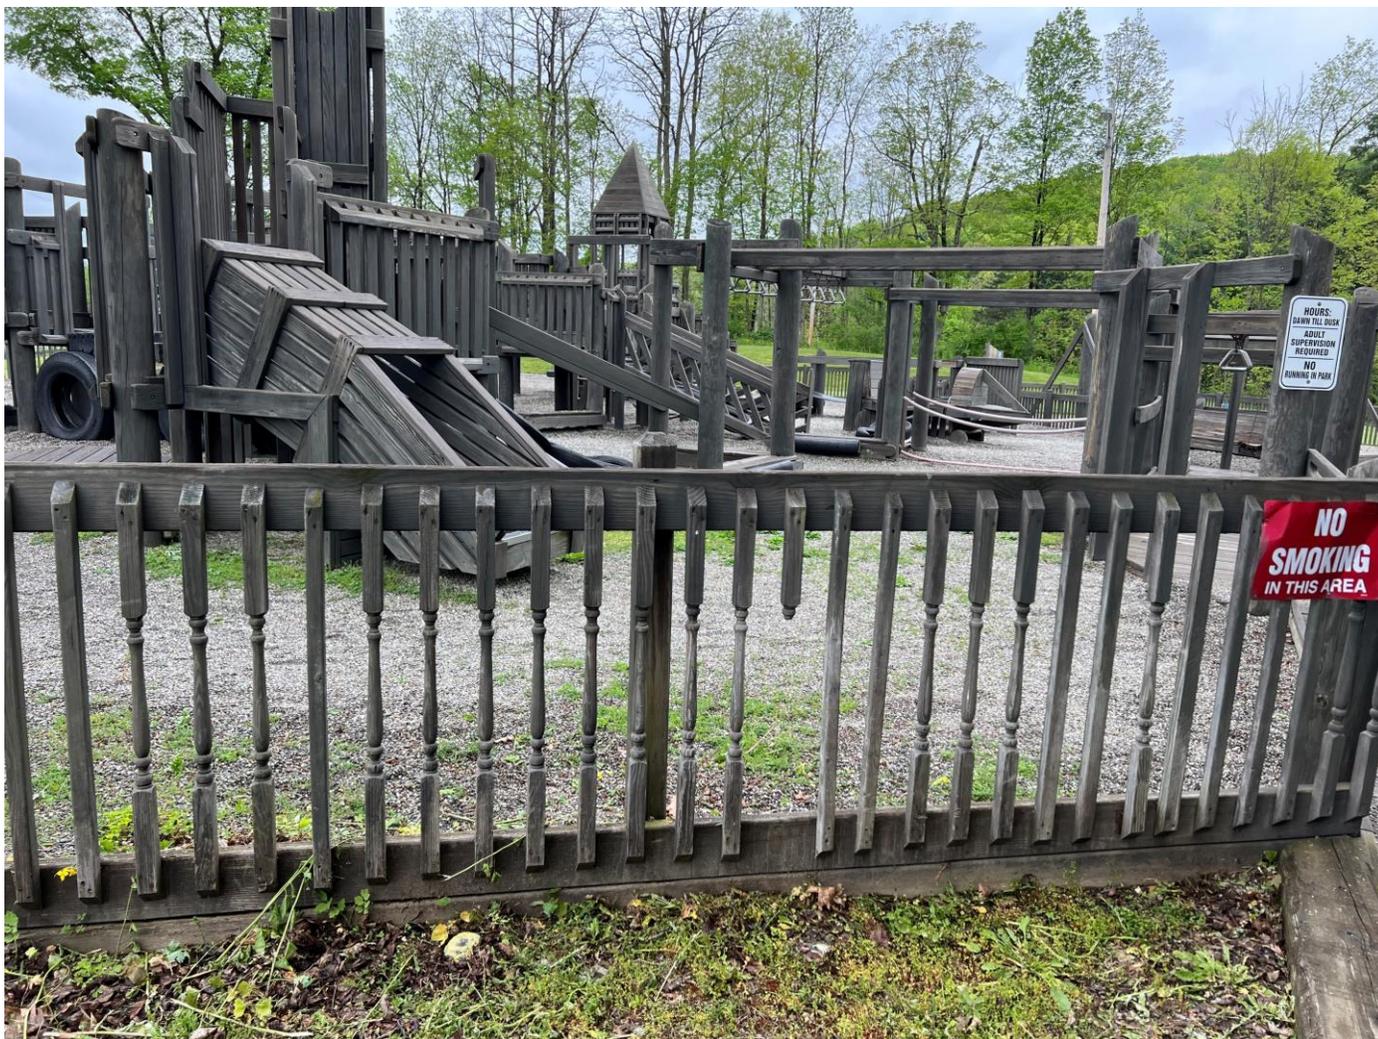
Fence: *Fair Condition*

Issues: Missing some pickets or has broken pickets. Some movement from years of frost. Posts and 2x6 rails are in fair condition. Fence shows some signs of splitting.

Recommendation: Repair and replace broken and missing pieces. Sand areas that are splitting and seal.

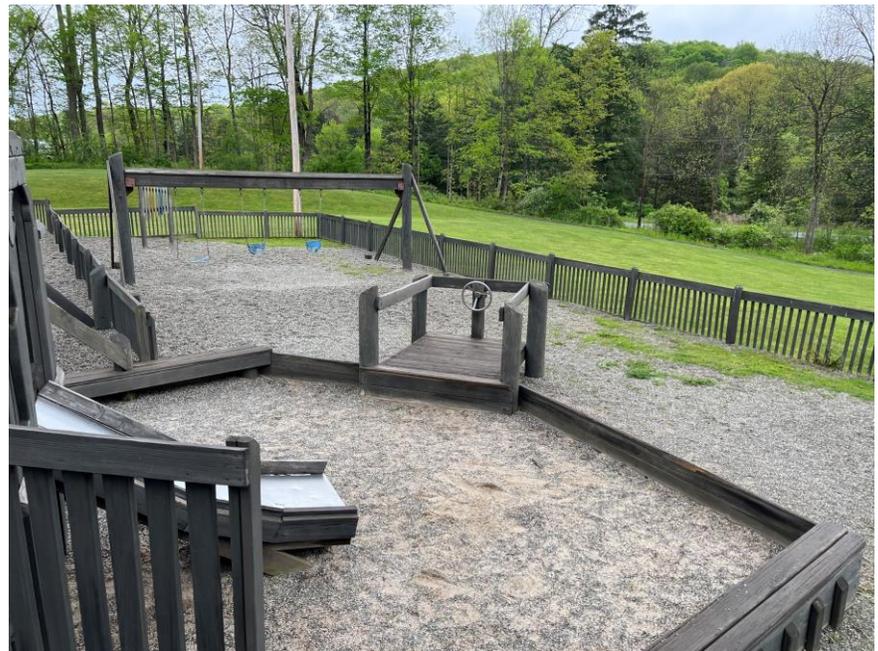
Play Element Steering Wheel :

Poor condition

Issues: The space between handles of the steering wheel creates a head entrapment. (**Priority 1**). Space is over 3-1/2" and less than 9".

Recommendation: Remove

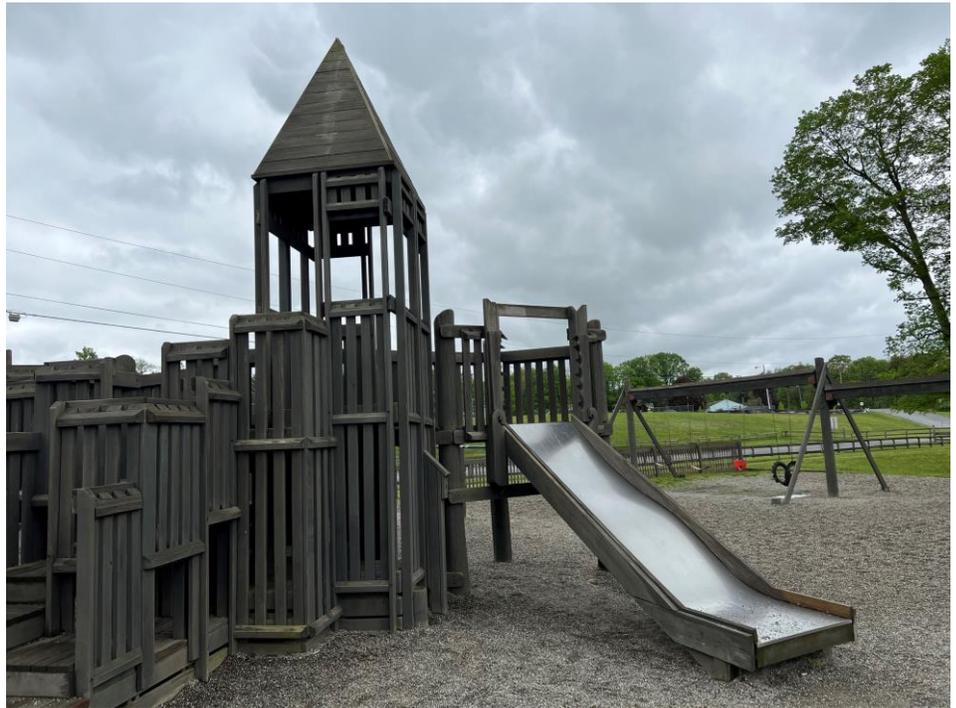
Play Element Tot Slide and

Structure: *Poor condition*

Issues: Structure is in poor condition, showing signs of sever splitting and protruding screws causing entanglement issues.

(Priority 1) Recommendation:
Remove

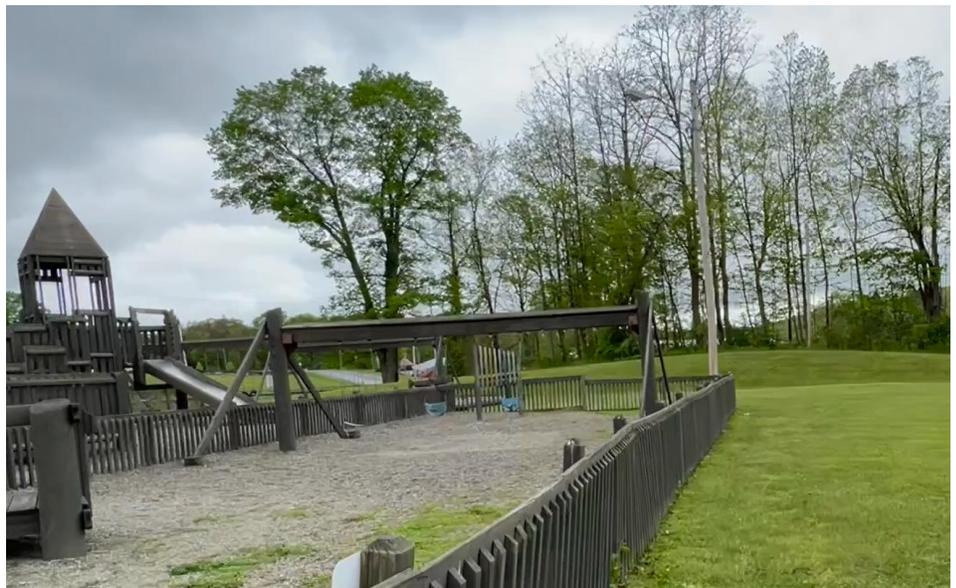
Play Element 2-5 Swings: *Poor condition*

Issues: S-Hook opening is an entanglement hazard ($>0.04''$) .
(Priority 1). More than 2 threads at swing hanger causing a protrusion **(Priority 1)**. Swing are too close to fence, must be 6' or more away from any objects. Too many swings in one bay

Recommendation: Remove and replace with new manufactured swings

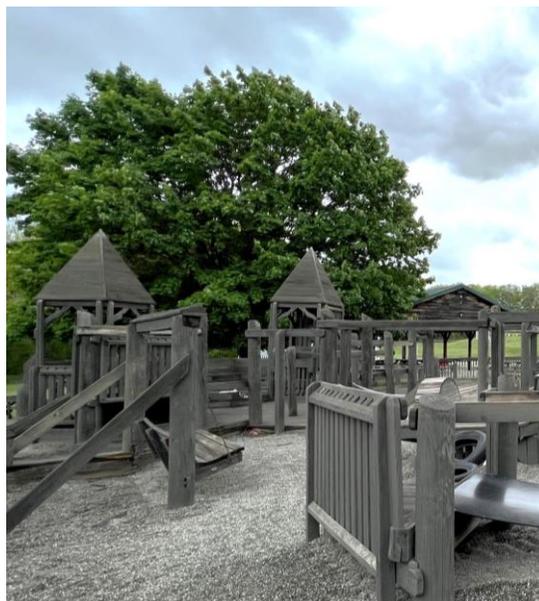
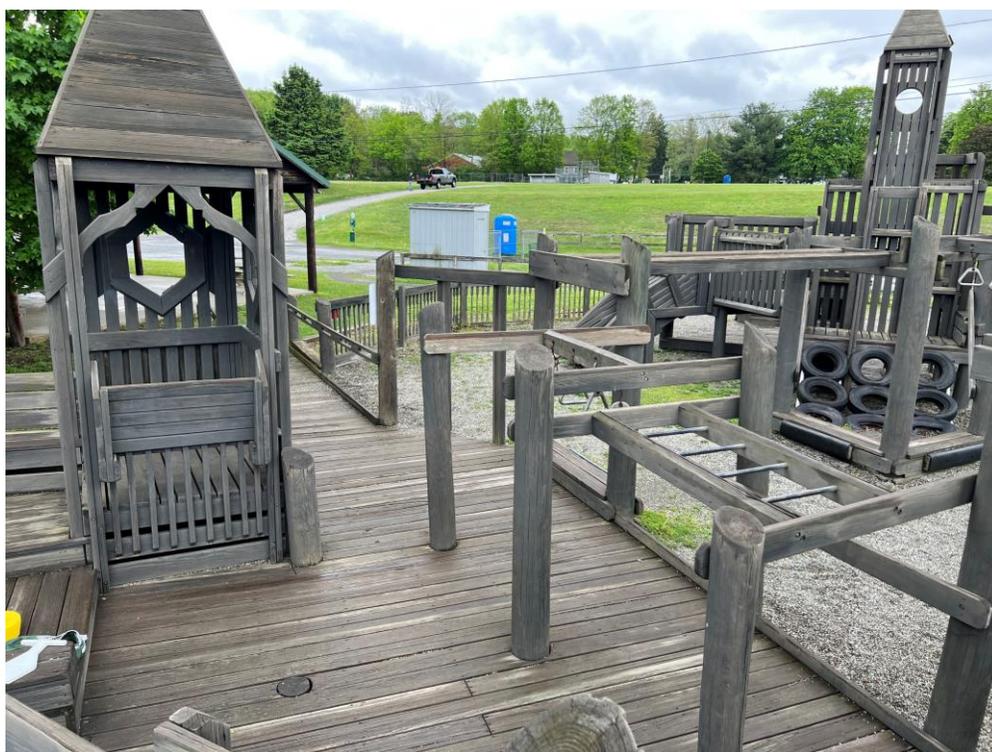
Play Element Swinging Bench: *Poor condition*

Issues: Not suitable for playground use. (**Priority 3**)

Recommendation: Remove and replace with new manufactured swings

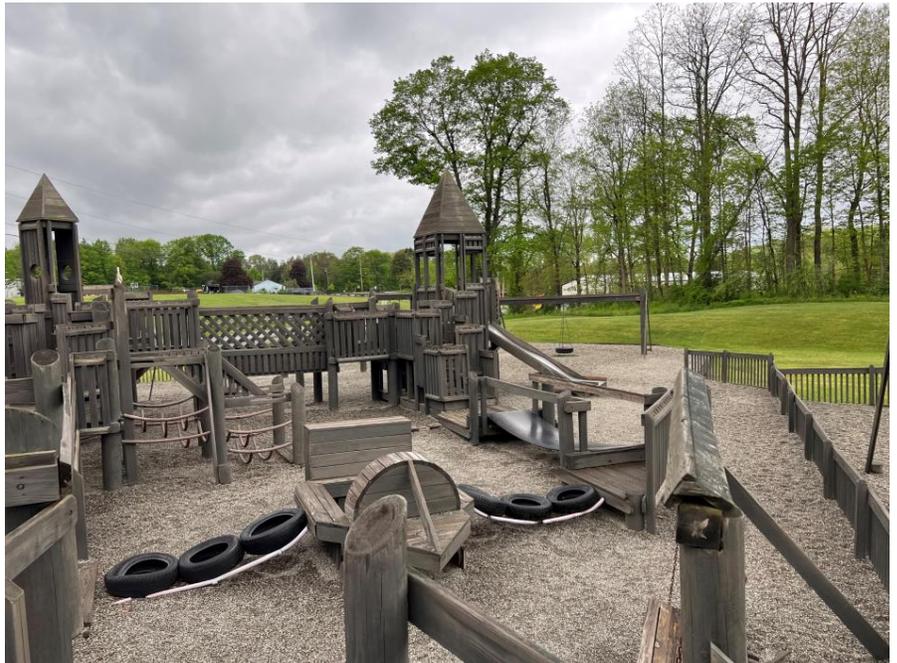
Play Element Chain Bridge: *Poor condition*

Issues: Chains are very loose and allowing it to turn on each other which creates a head entrapment. **(Priority 1)** (space over 3-1/2" and less than 9"). Quick links are open, will not close properly. Some signs of rusting. Vertical and 2x6 bracing is showing signs of cracking and splitting. Missing chain cap at entrance. There are multiple 15" openings causing entrapments (space over 3-1/2" and less than 9"), should not be able to create a loop > 5" inside perimeter **(Priority 1)**

Recommendation: Remove and replace with new compliant net that's made of newer material.

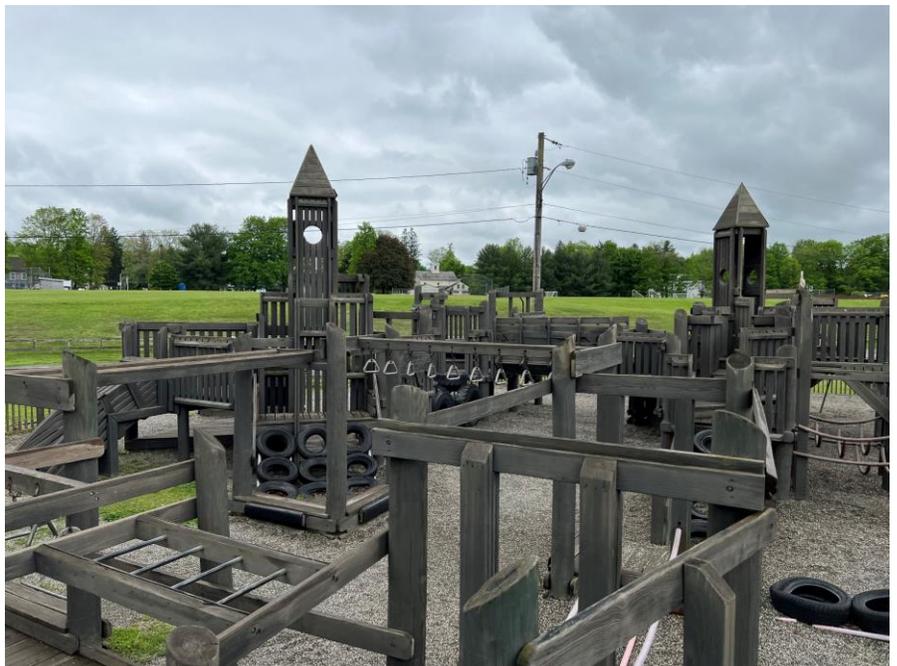
Play Element High Rings: *Poor condition*

Issues: S-Hook opening is an entanglement hazard (>0.04") . **(Priority 1)**. 2x10 header splitting. 2x6 ring beam splitting.

Recommendation: Remove and replace with new compliant net that's made of newer material.

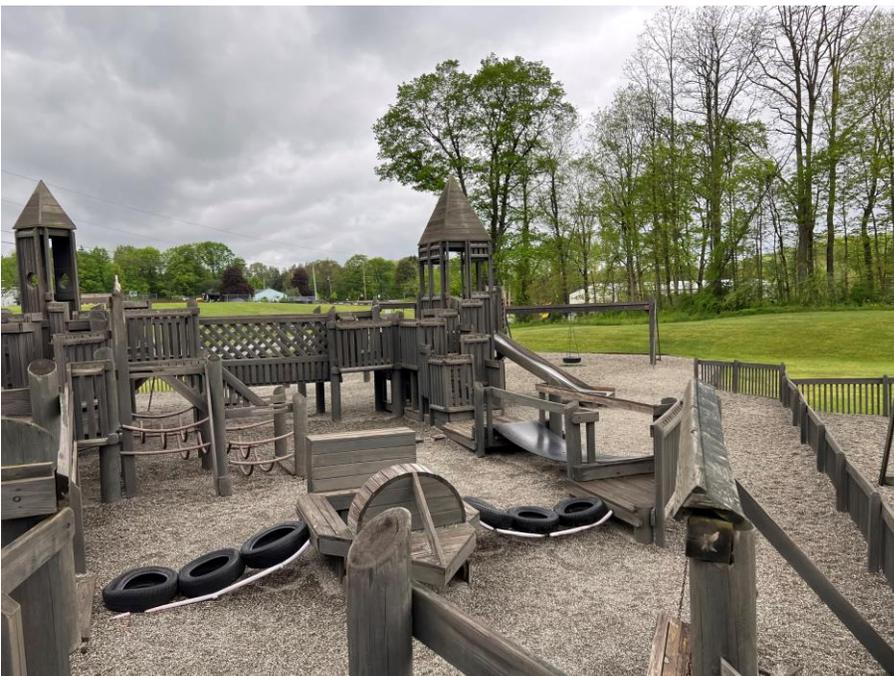
Play Element Bouncer: *Poor condition*

Issues: Wood is splitting and cracking. Head trap at steering wheel. (Priority 1) Head trap between tire and chains. (Priority 1) Protrusions from bolts connections to tire to chains. (Priority 1)

Recommendation: Remove and replace with new compliant net that's made of newer material.

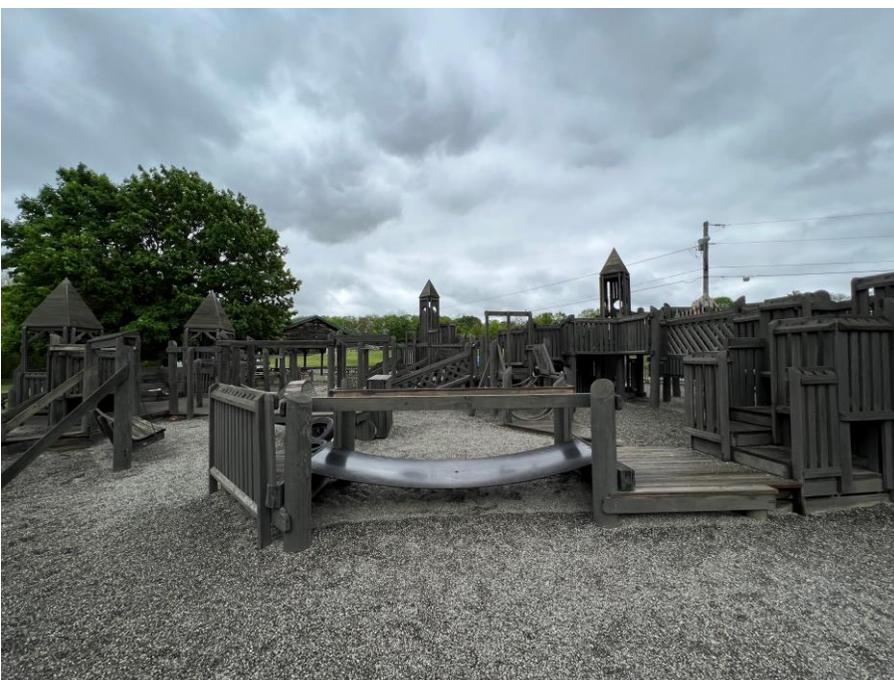
Play Element Rubber Bridge: *Poor condition*

Issues: Rubber bridge has protruding nails. (Priority 1) Rails are splitting and cracking. 2x8 headers are splitting and cracking. Standing surfacing, created by 2" or greater walkable surface at top of 2x4 corner posts. (Priority 3)

Recommendation: Remove and replace.

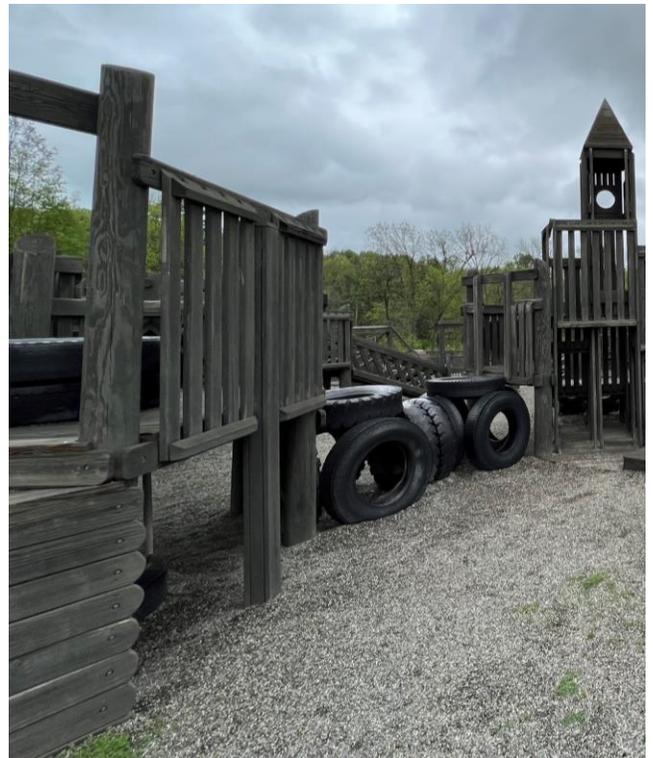
Play Element Tire Cube Climber: *Poor condition*

Issues: Head trap between tires connections. Head trap between posts and tires and ends. (Priority 1). Opening at top is over 15", causing entrapments (space over 3-1/2" and less than 9"), should not be able to create a loop > 5" inside perimeter (Priority 1). No hand grasping component at top.

Recommendation: Remove and replace.

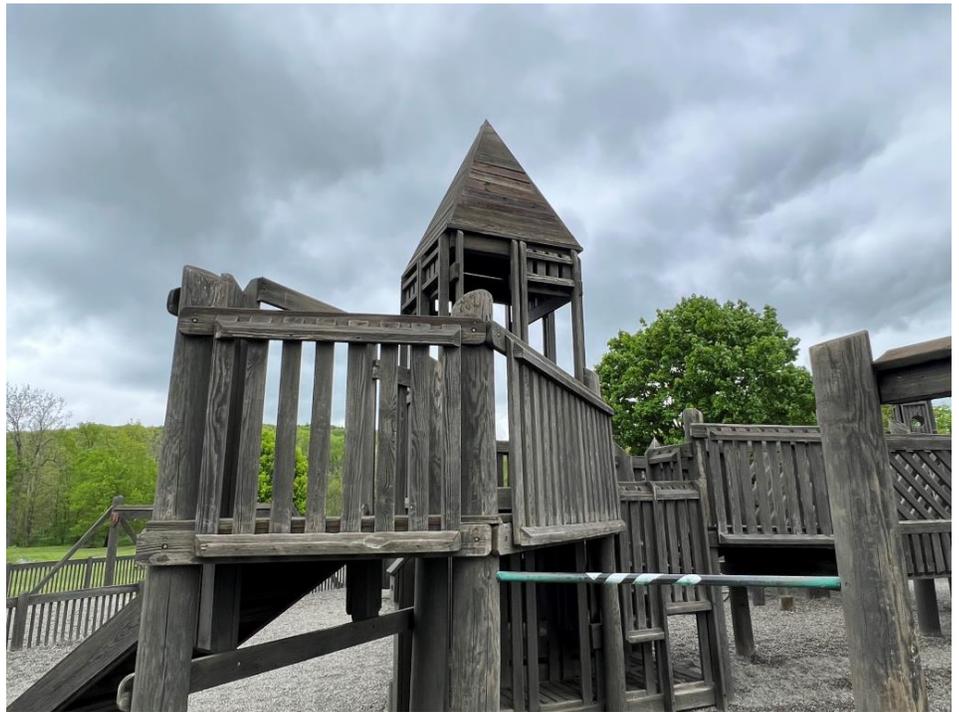
Play Element Chin Bar: *Fair condition*

Issues: Good condition, dark colored which makes it difficult to see.

Recommendation: Paint the bar with a bright color for better visibility.

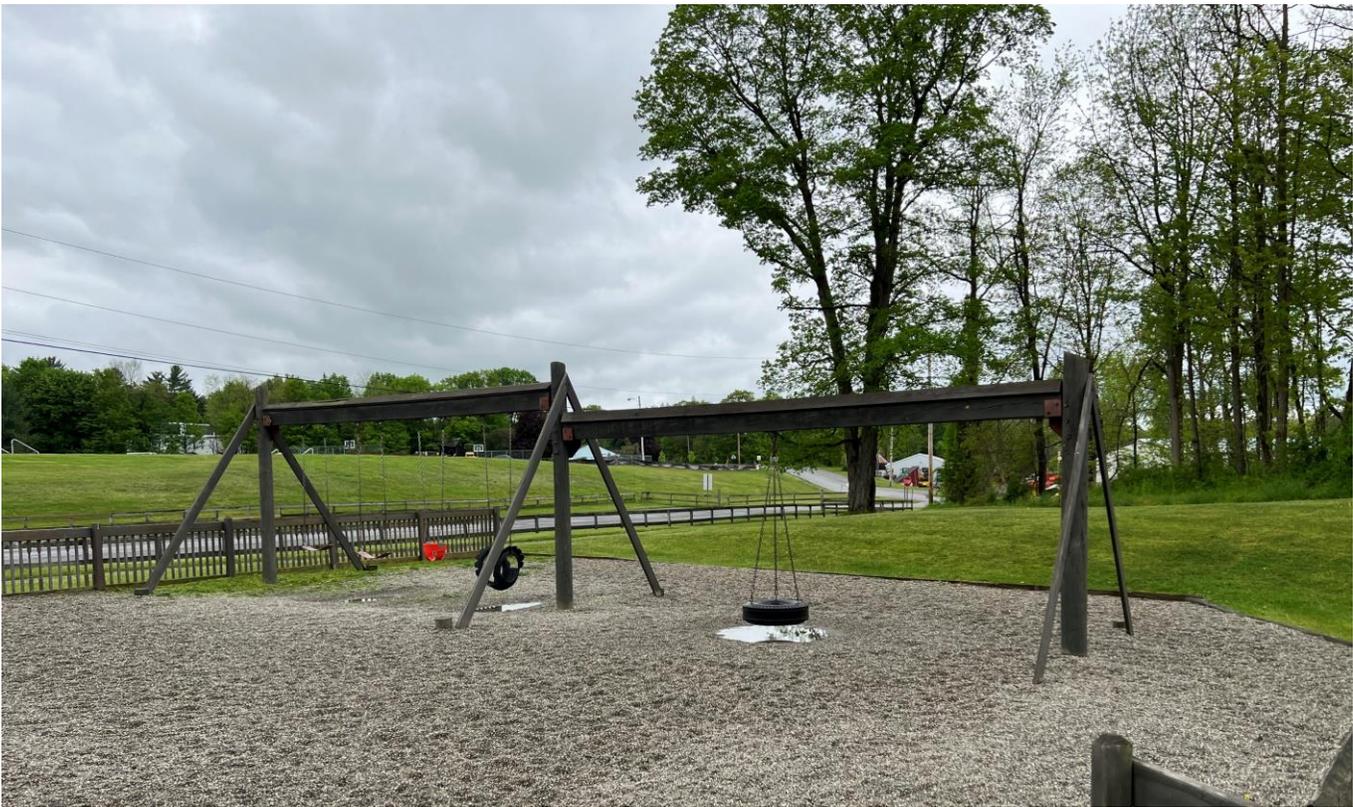
Play Element Trolley: *Poor condition*

Issues: There is no braking system in place. (**Priority 1**) Hardware is protruding and showing signs of rust. (**Priority 1**) 2x6 header in fair condition, 2x6 cap is splitting and aging.

Recommendation: Remove track ride.

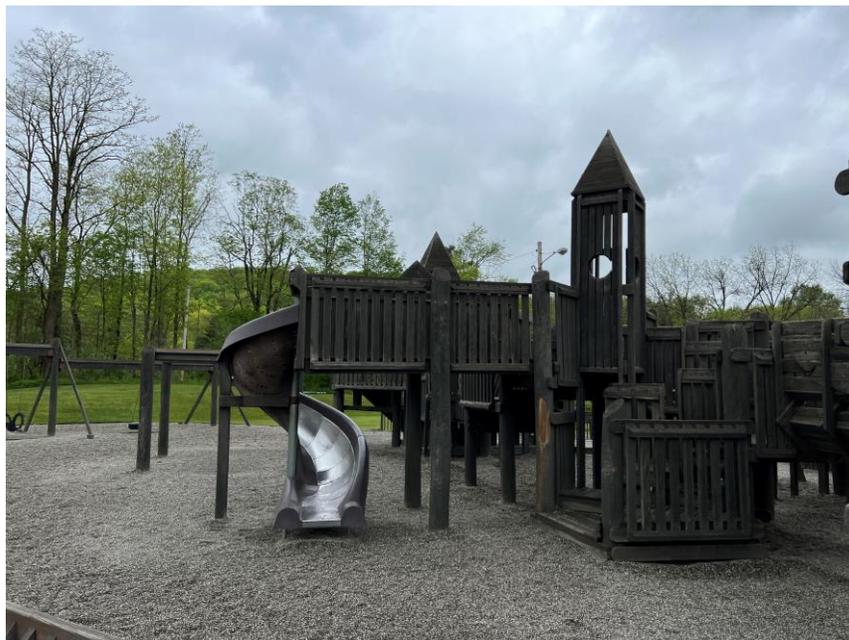
Play Element Spiral Slide: *Poor condition*

Issues: Bolts and nuts are protruding causing entanglement issues (**Priority 1**). Clearance between slide and the bottom of the deck are too close. (**Priority 1**). Slide is showing stress crack at bottom. Wood deck is splitting and cracking (**Priority 1**). Exposed screws and nuts. Board are pulling away. **Recommendation:** Remove and close off.

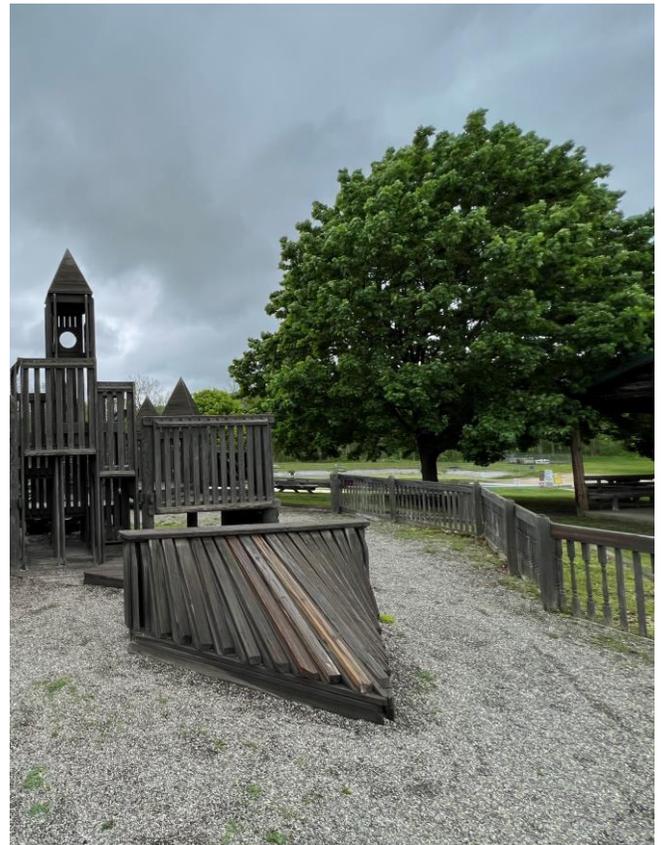
Play Element 5-12 Train: Poor condition

Issues: The space between handles of the steering wheel creates a head entrapment. (Priority 1). Space is over 3-1/2" and less than 9". Greater than 2" walkable surfacing, surface at top of 2x6 (Priority 2). Wood is splitting. Protruding screws.

Recommendation: Remove steering wheel, replace with new. Route edges with 1/4" radius so the top of the boards is less than 2" of a flat surface.

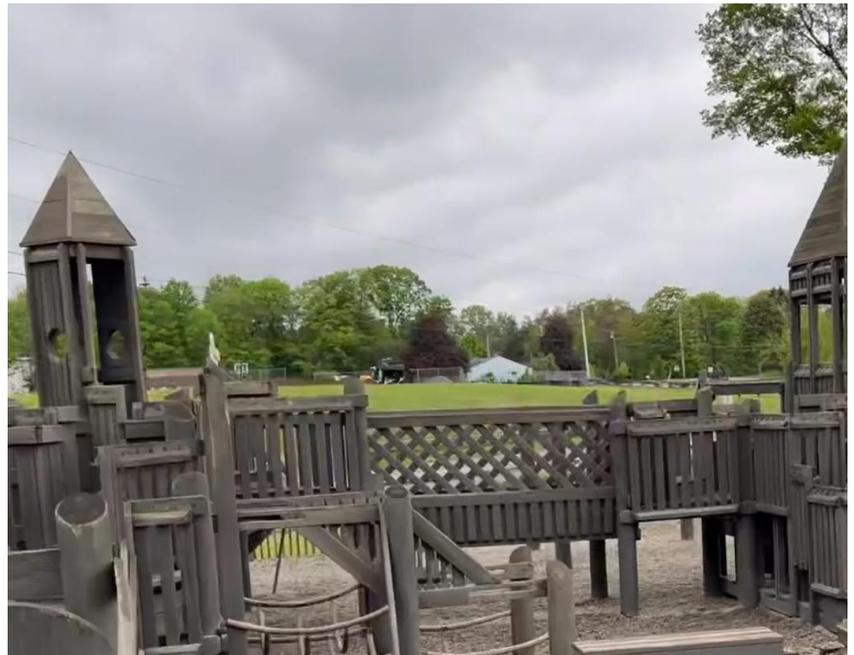
Play Element Suspension Bridge: Fair condition

Issues: Suspension bridge chains are very loose. (Priority 5) Boards are splitting and cracking. Head entrapment between diagonal balusters (Priority 1). Space is over 3-1/2" and less than 9". Exterior wood is poor condition, showing signs of rot and splitting. Pinch points between planks and side structure.

Recommendation: Tighten chains under the bridge, new suspension bridge hardware kit is available, contact PBD for replacement recommendation. Replace old boards. Close head tr
